**DRAFT FINAL REMEDIAL ACTION SITE CLOSURE REPORT  
OPERABLE UNIT 3, INSTALLATION RESTORATION SITE 1F  
43 AREA REFUSE BURNING GROUND  
CAMP PENDLETON, CALIFORNIA**

**Document Control Number 6472  
Revision 0**

**August 6, 2003**

**DRAFT FINAL REMEDIAL ACTION SITE CLOSURE REPORT**  
**OPERABLE UNIT 3, INSTALLATION RESTORATION SITE 1F**  
**43 AREA REFUSE BURNING GROUND**  
**CAMP PENDLETON, CALIFORNIA**

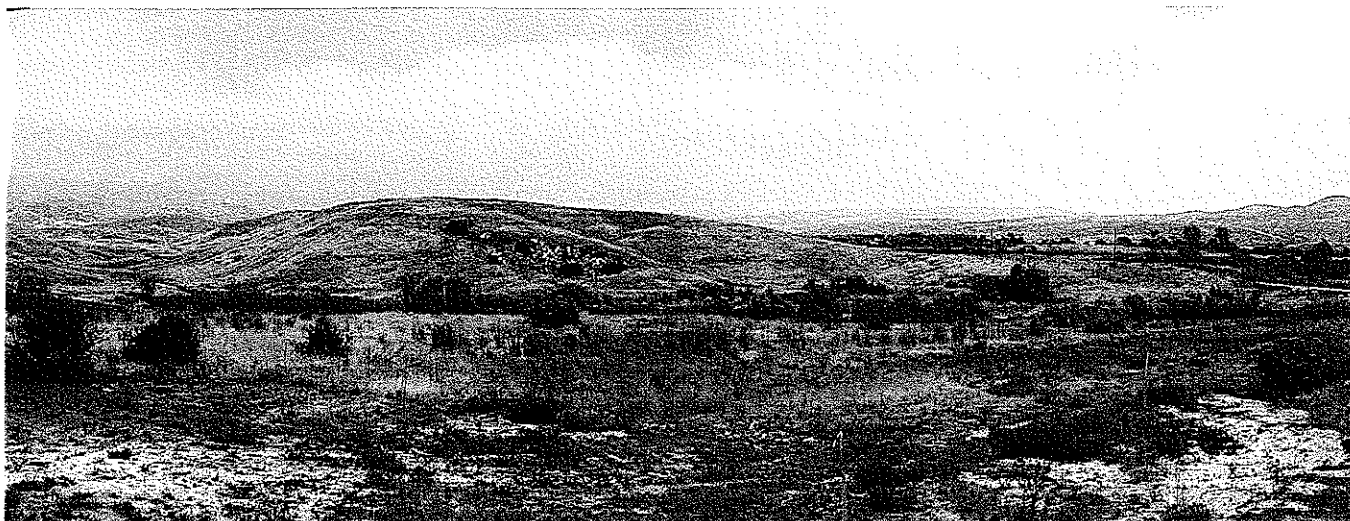
Photograph No. 1: Site 1F Before Soil Removal Activities (June 21, 1999)  
Photo Control Location (PCL) #4

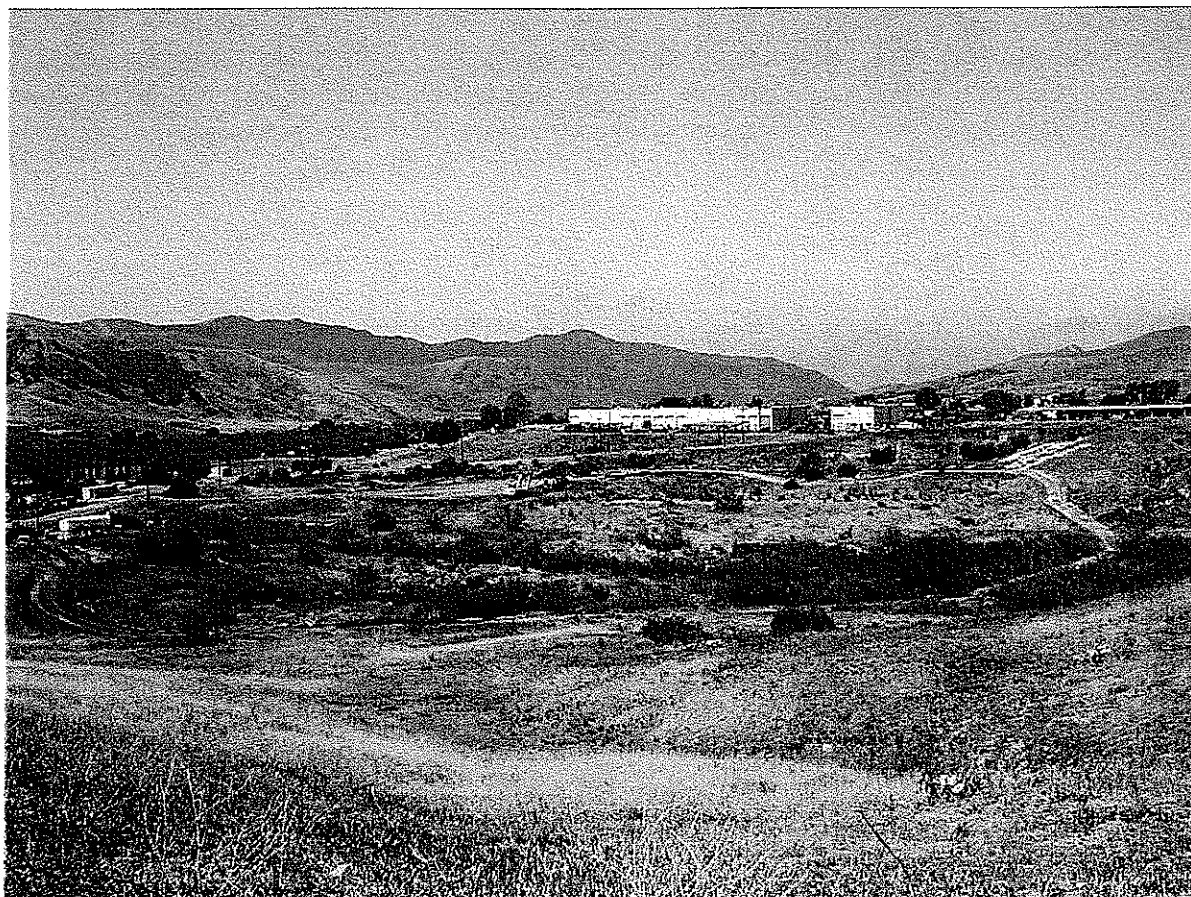
Photograph No. 2: Site 1F Prior to Clearing And Grubbing (June 25, 1999)  
PCL # 1

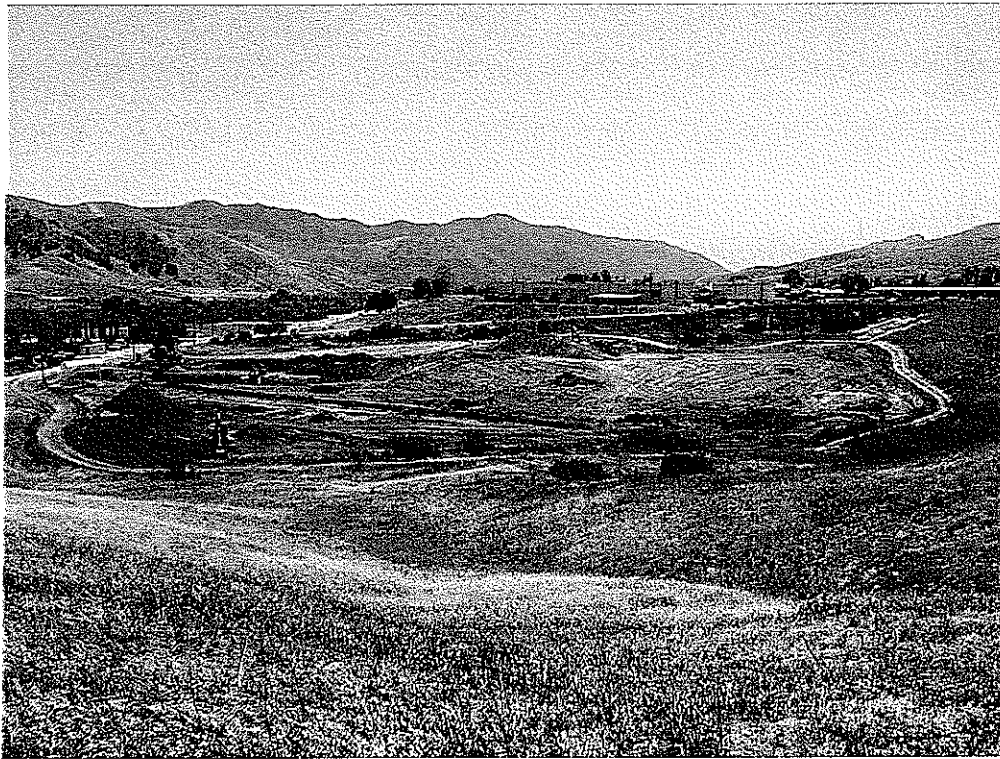
Photograph No. 3: Second Day of Excavating and Stockpiling Activities (June 29, 1999)  
PCL # 1

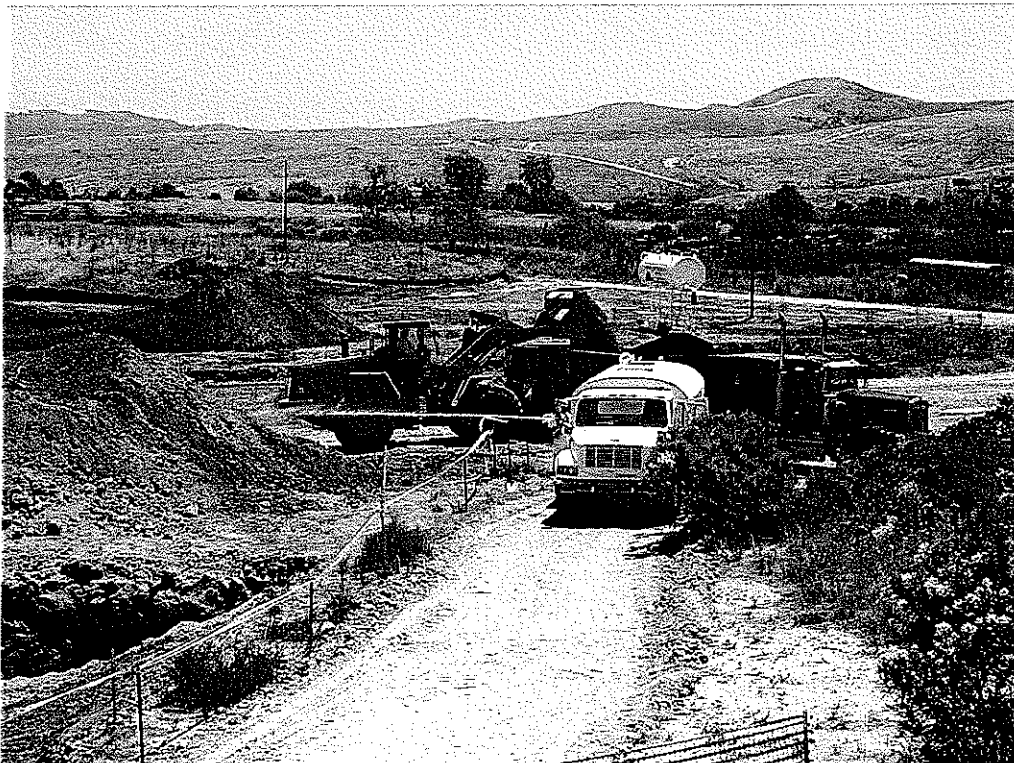
Photograph No. 4: First Day of Loading Contaminated Soil for Transport to CAMU (June 30, 1999)  
PCL # 4

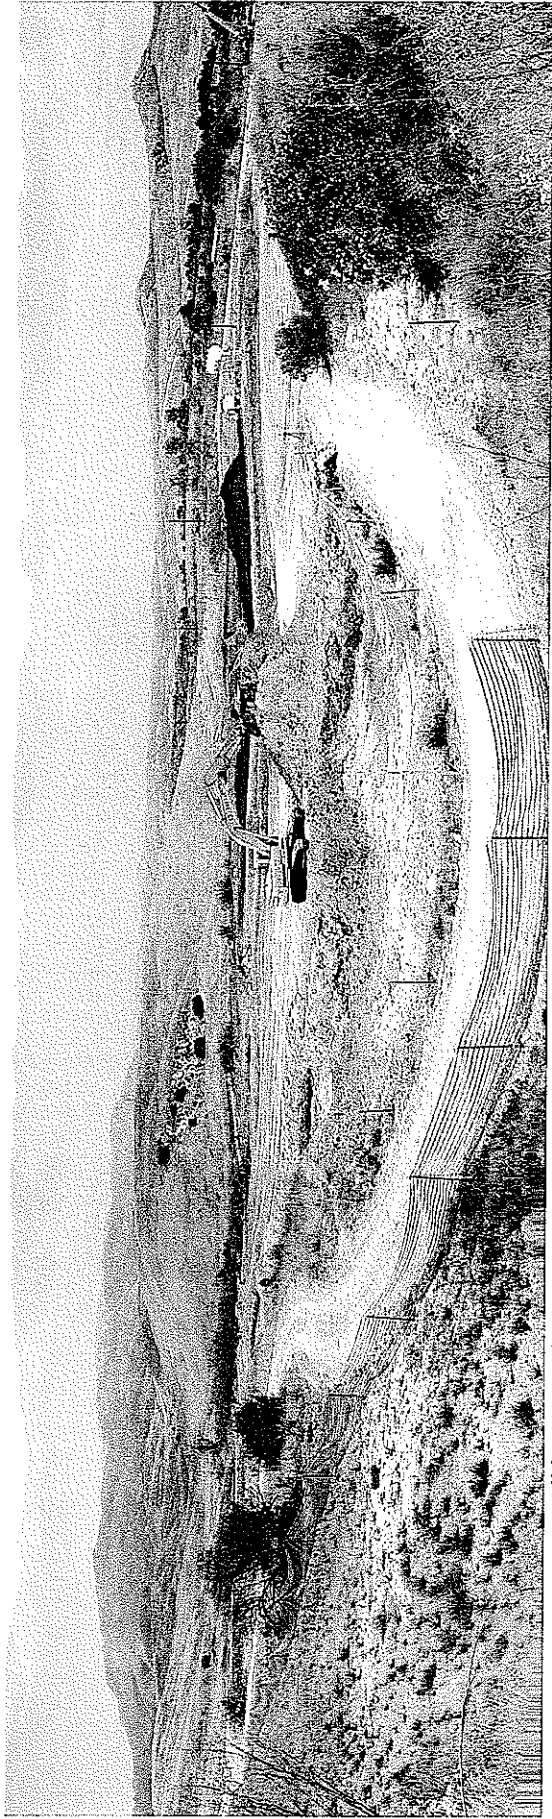
Photograph No. 5: Site 1F Excavating and Stockpiling Activities Western Area (July 7, 1999)  
PCL # 4

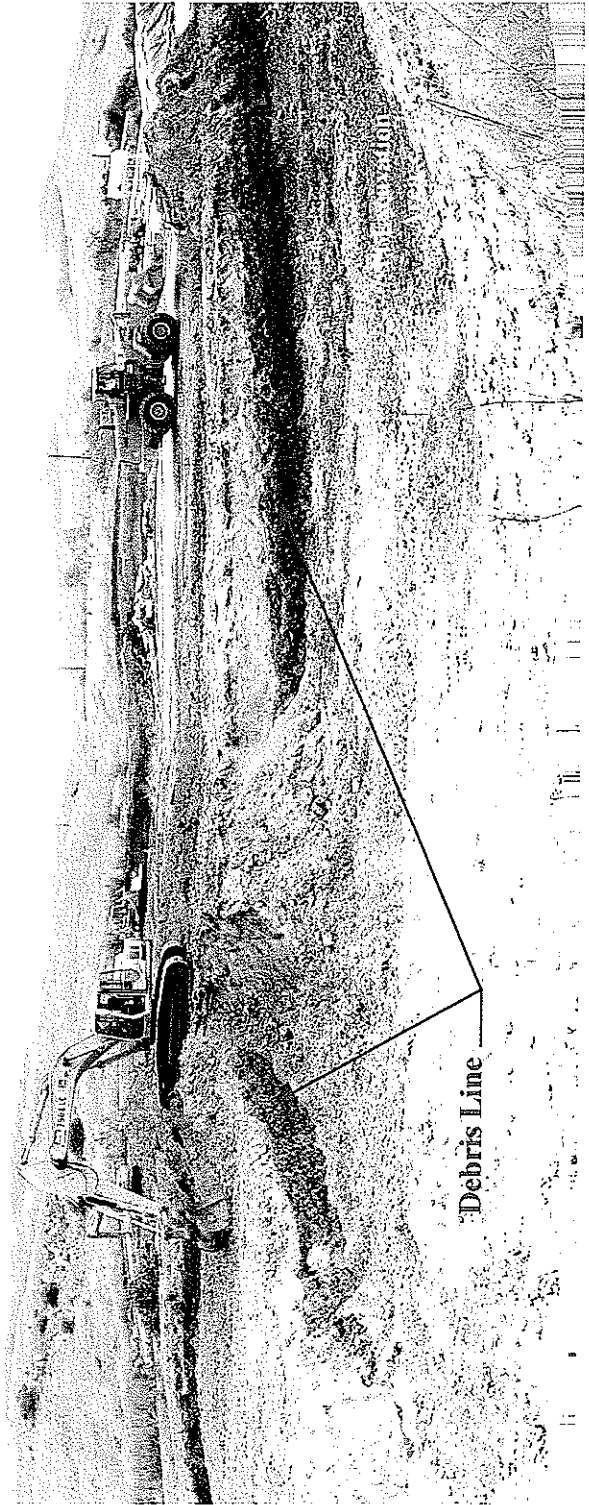
Photograph No. 6: View of Debris Line Encountered Near Perimeter Location 1F-1147 (July 9, 1999)

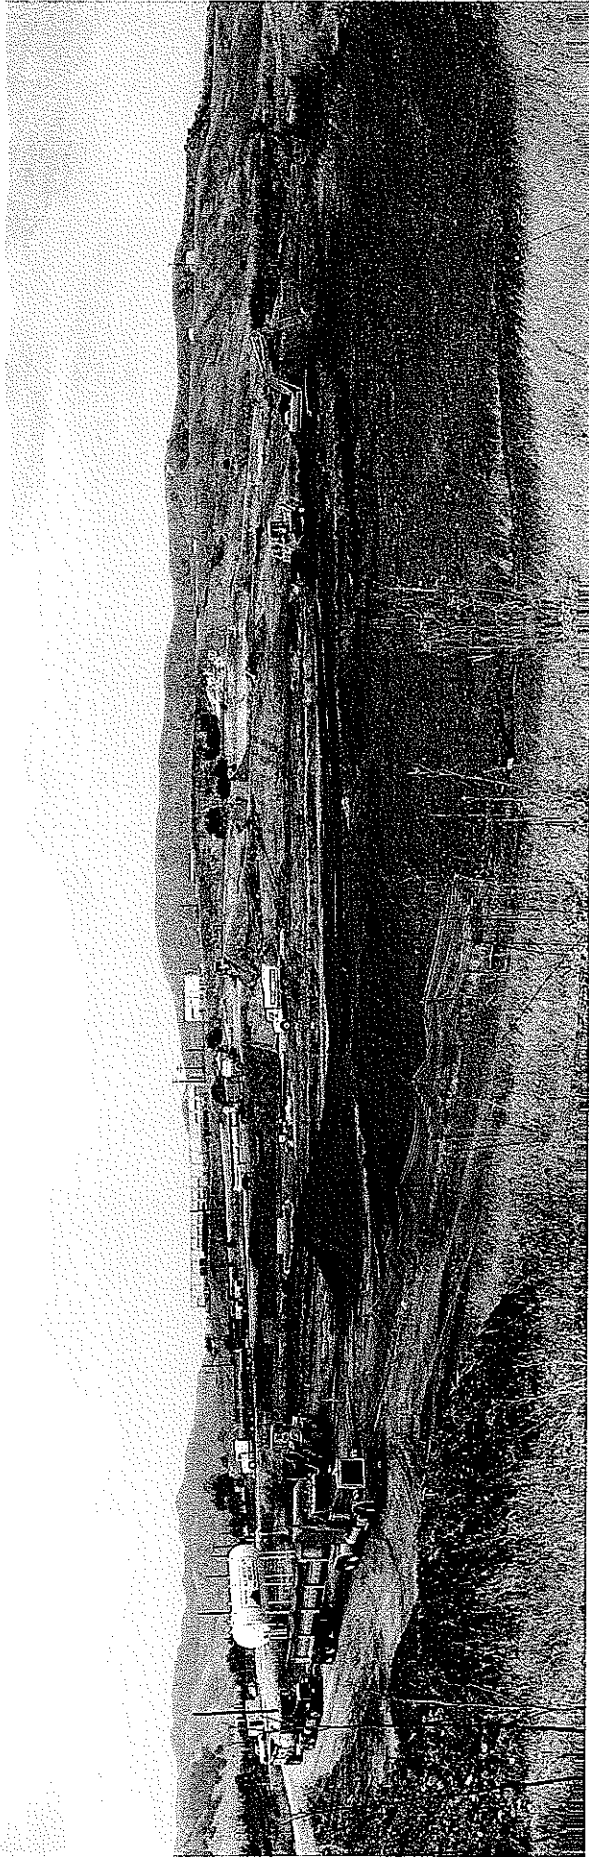
Photograph No. 7: Site 1F Remedial Activities Eastern Area (July 9, 1999)  
PCL # 3

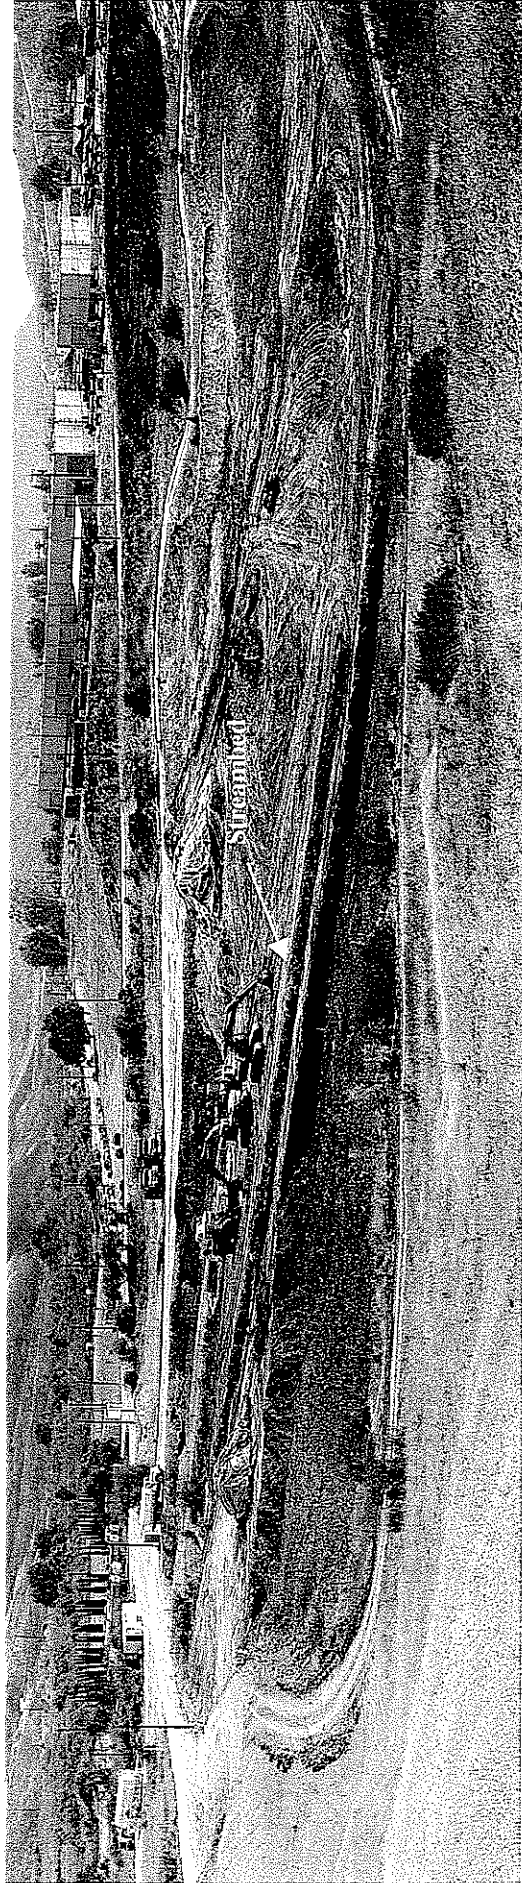
Photograph No. 8: Site 1F Remedial Activities in Progress (July 13, 1999)  
PCL # 1

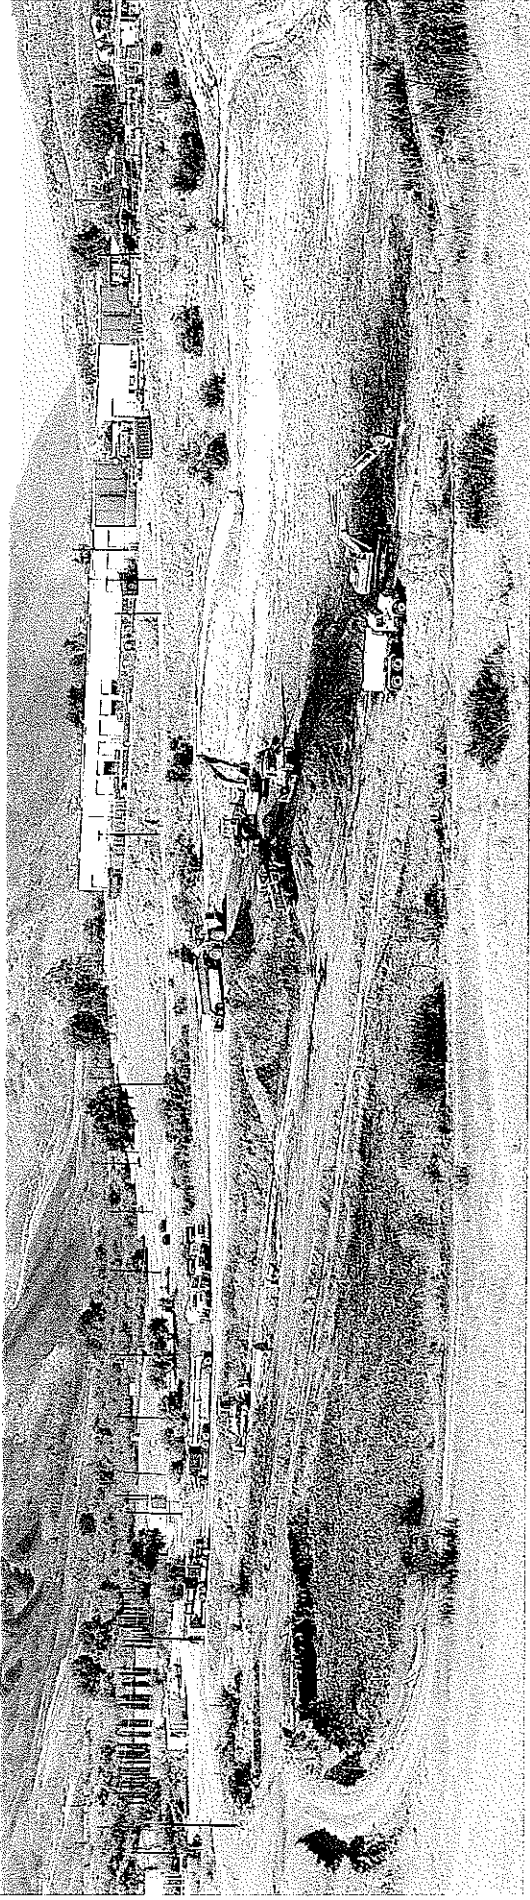
Photograph No. 9: Site 1F Remedial Activities in Progress (July 16, 1999)  
PCL # 1

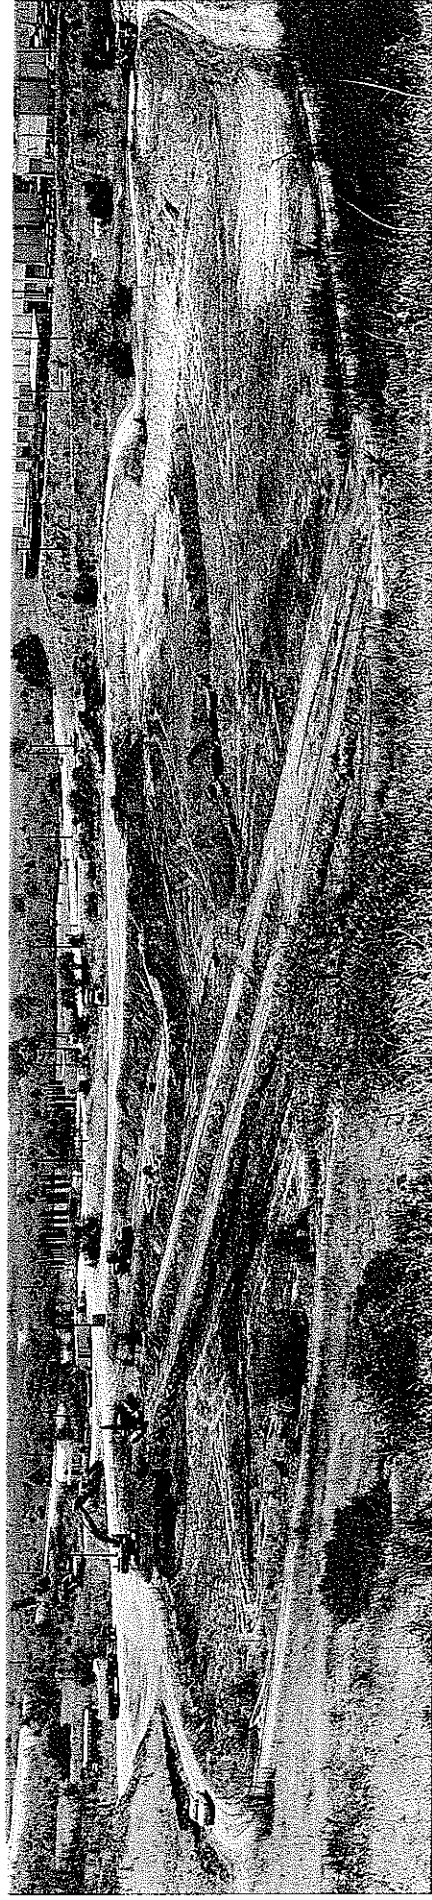
Photograph No. 10: Site 1F Remedial Activities in Progress (July 26, 1999)  
PCL # 1

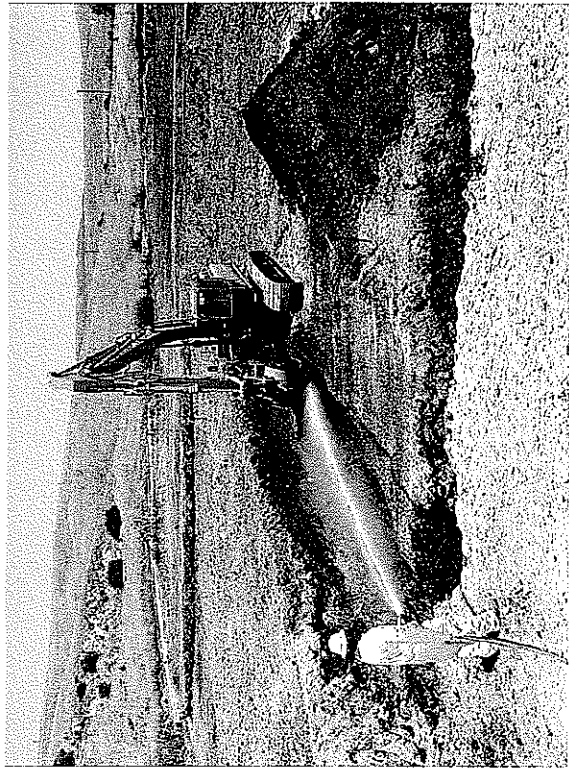
Photograph No. 11: Trenching Prior to Over-Excavation Activities

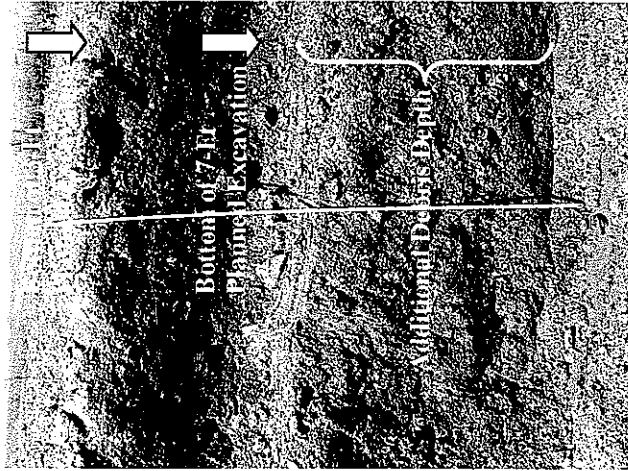
Photograph No. 12: Profile of Debris for Over-Excavation

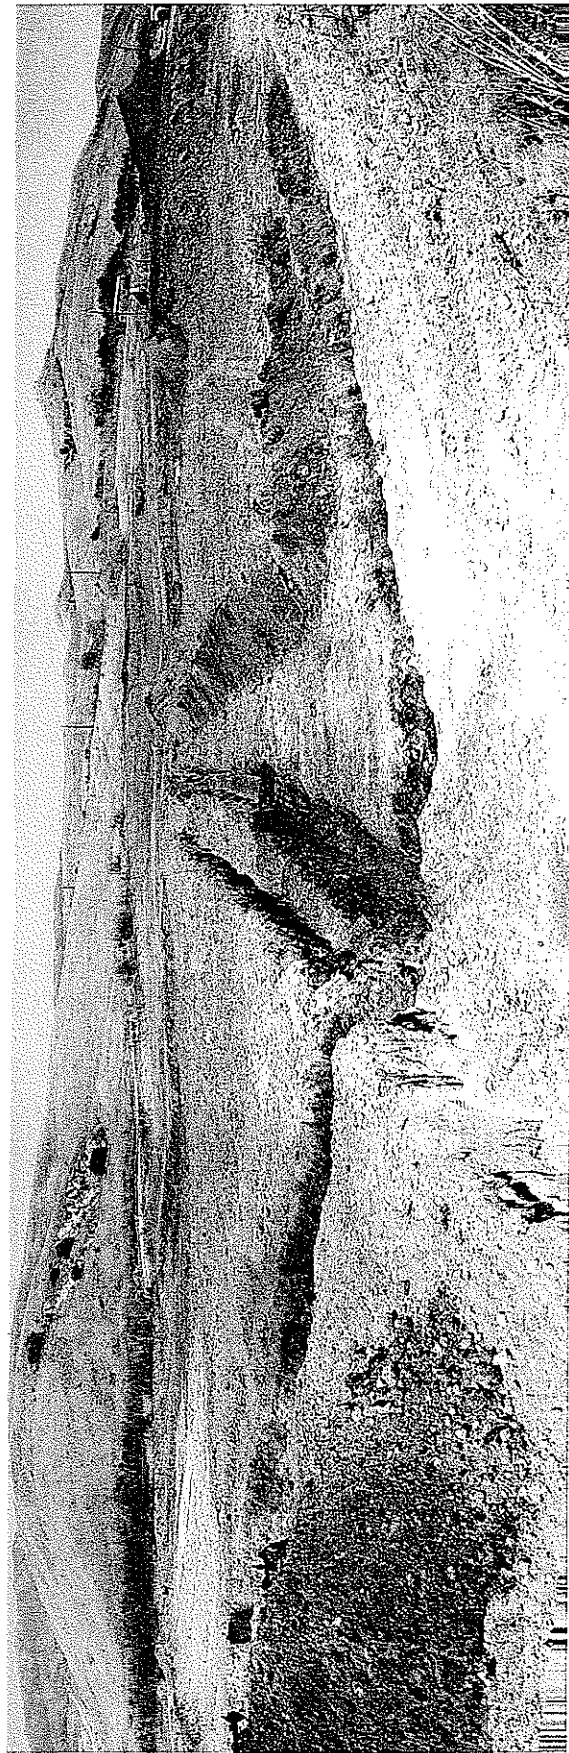
Photograph No. 13: View of Completed Test Trenches from Perimeter Location 1F-1147 (July 21, 1999)

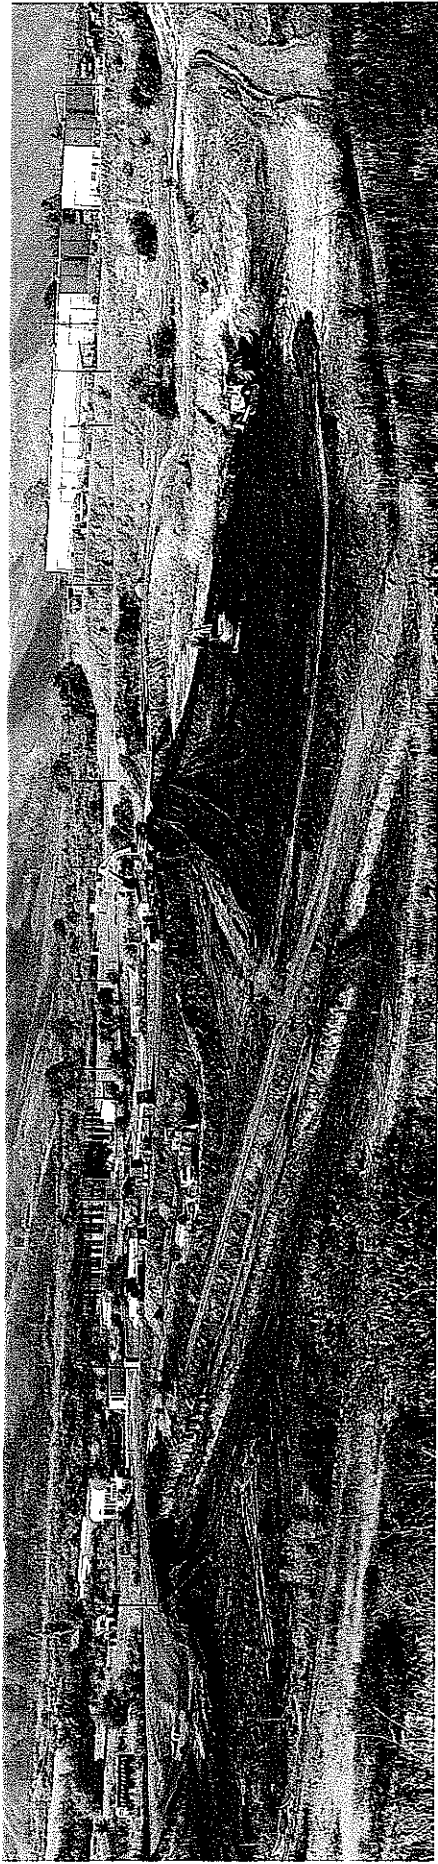
Photograph No. 14: Second Day of Over-Excavation Stage (July 29, 1999)  
PCL # 1

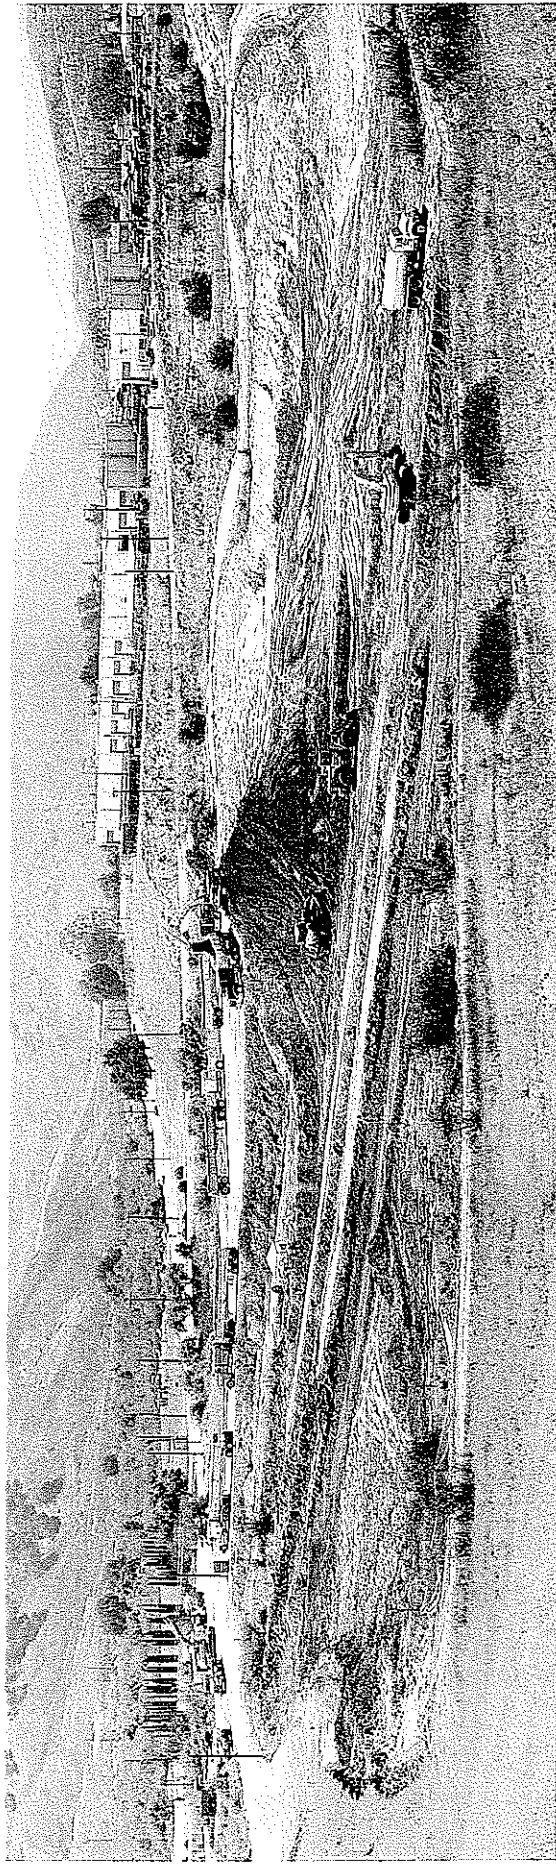
Photograph No. 15: Site 1F Over-Excavation Activities in Progress (August 4, 1999)  
PCL # 1

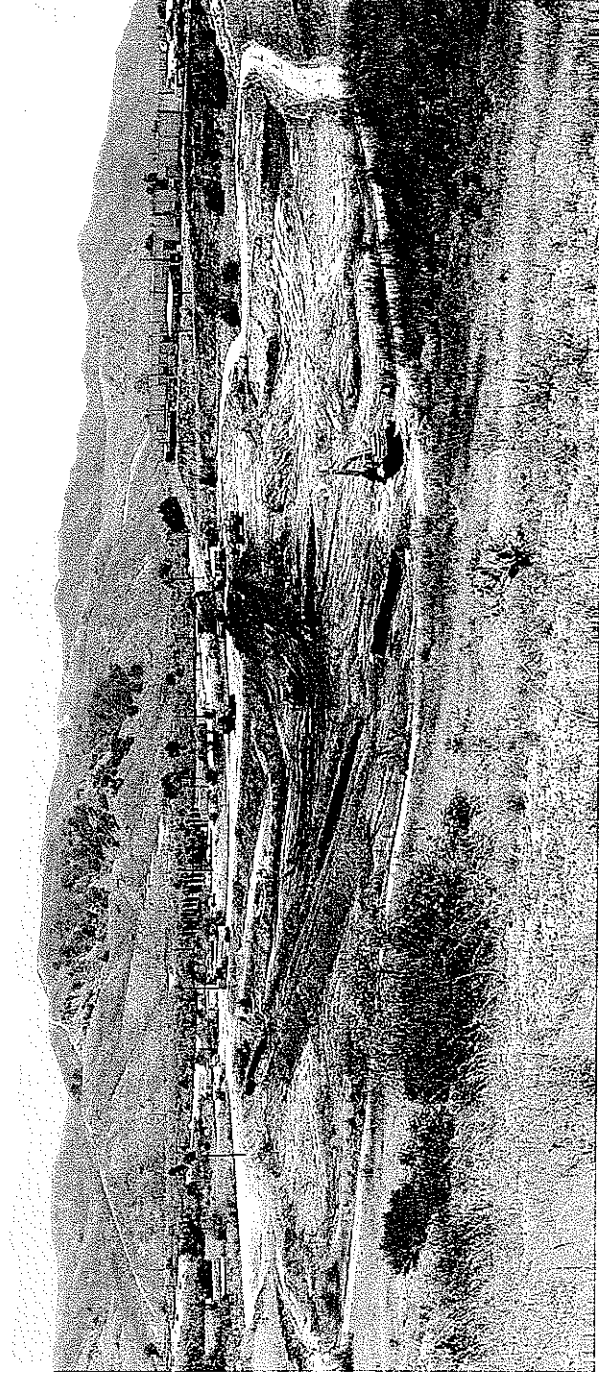
Photograph No. 16: Site 1F Over-Excavation Activities in Progress (August 9, 1999)  
PCL # 1

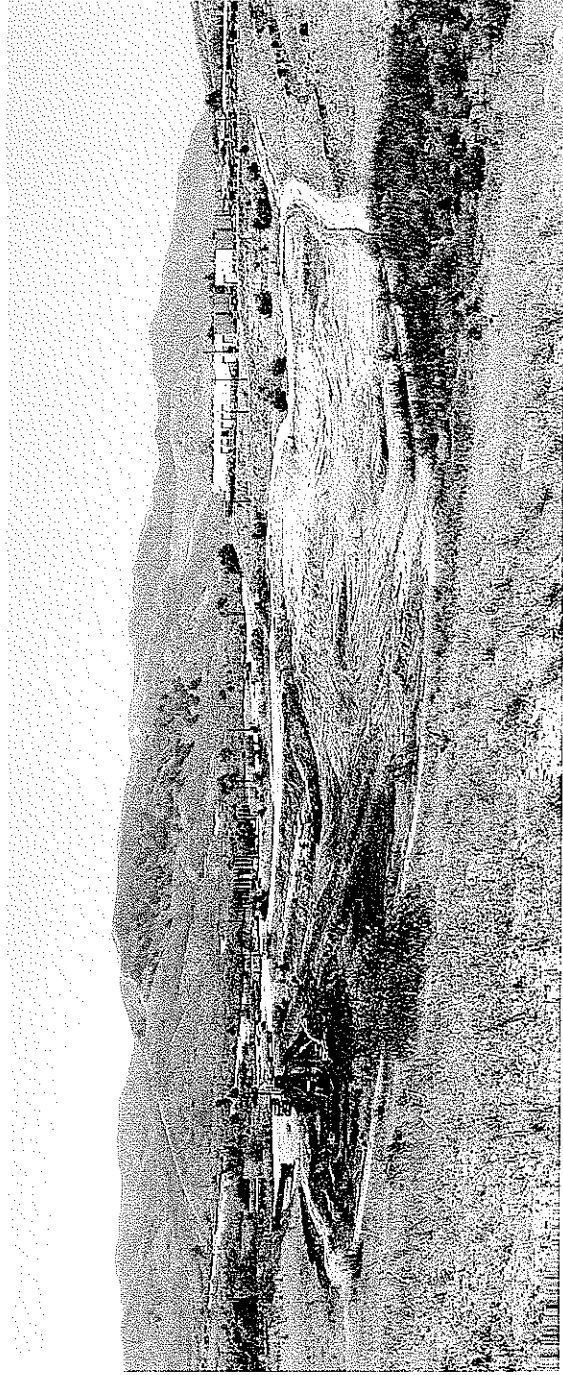
Photograph No. 17: Site 1F Over-Excavation Activities in Progress (August 12, 1999)  
PCL # 1

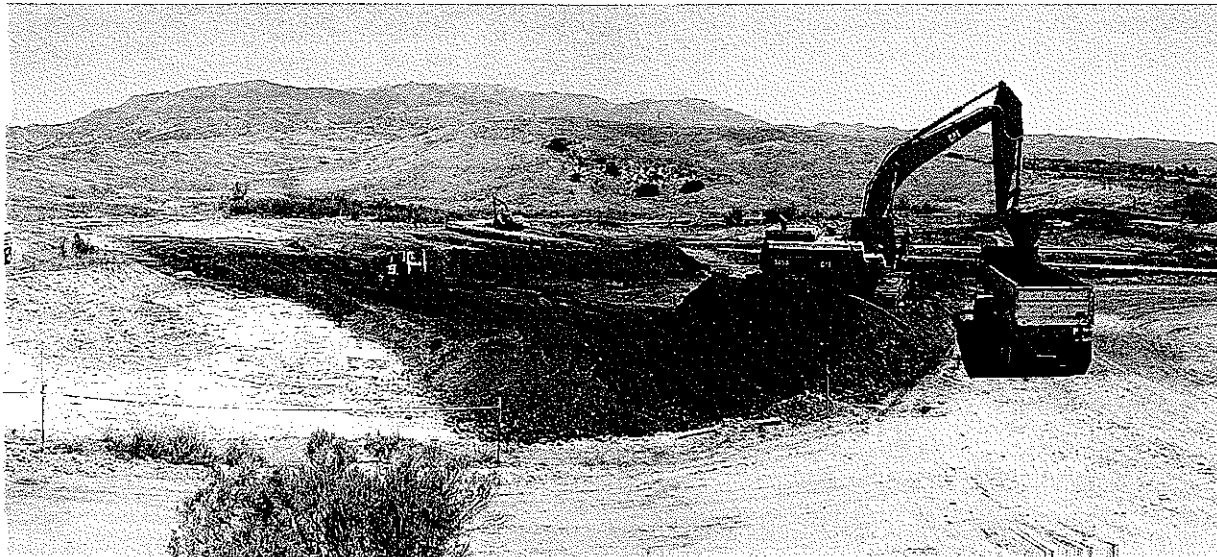
Photograph No. 18: Loading of Over-Excavation Soil from Western Area (July 30, 1999)  
PCE # 4

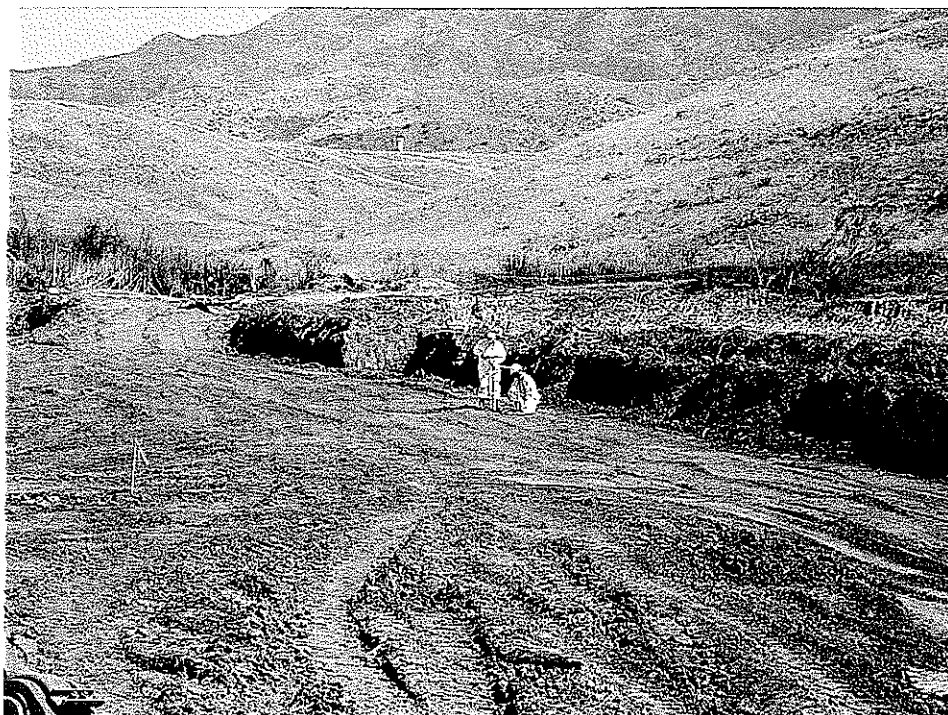
Photograph No. 19: Collection of Floor Confirmation Soil Samples From Location F3  
(August 23, 1999)

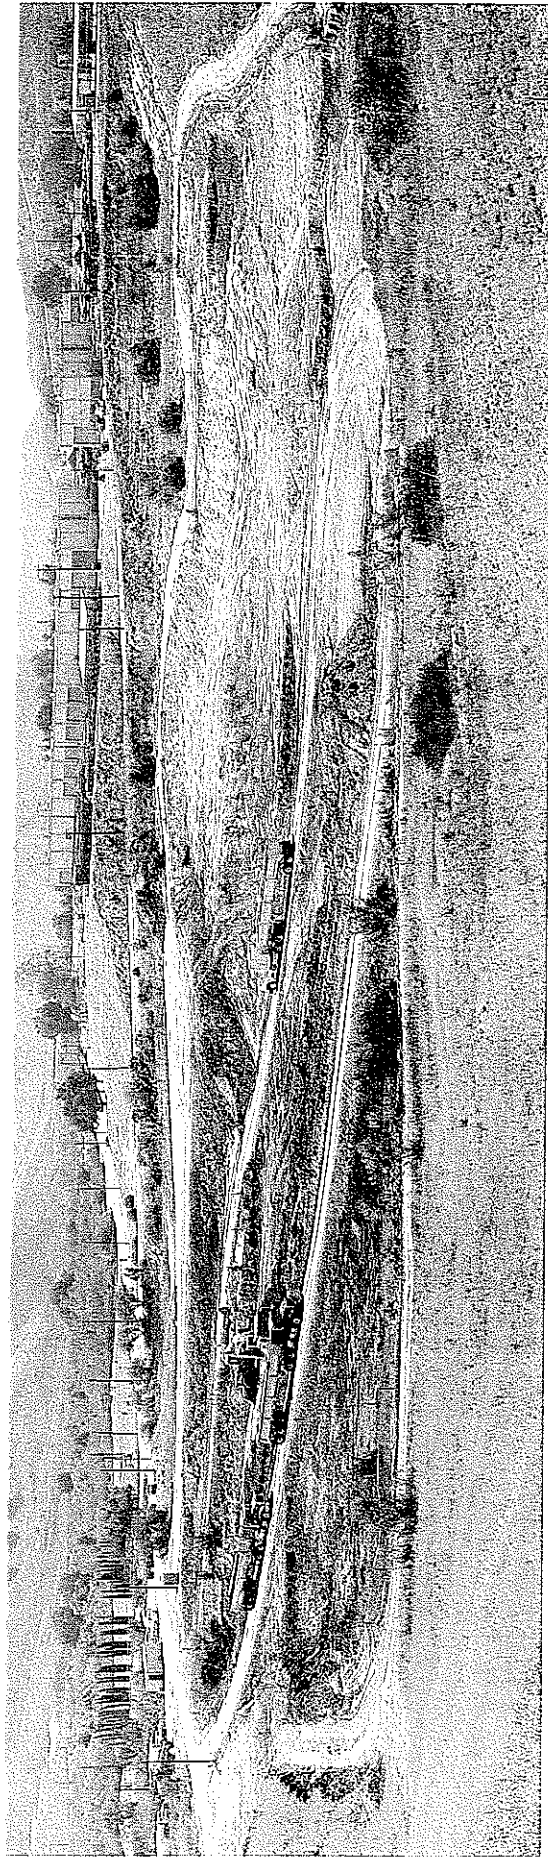
Photograph No. 20: Site 1F Streambed Soil Removal and Final Excavation Stage (September 8, 1999)  
PCL # 1

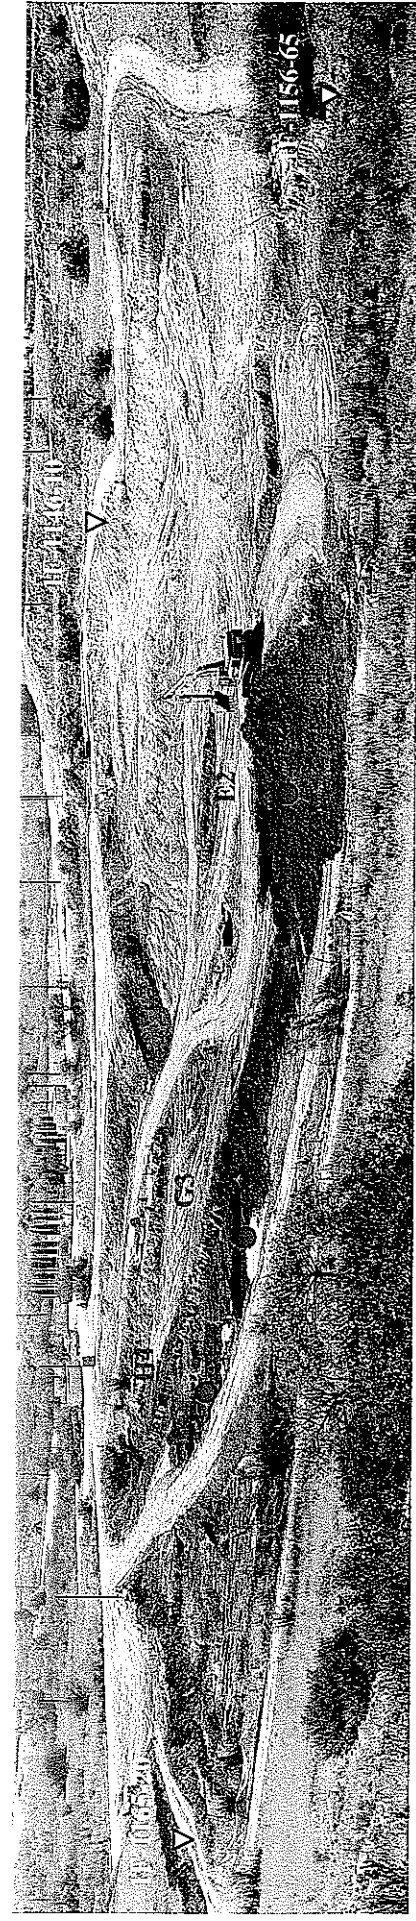
Photograph No. 21: Site 1F Final Excavation Stage Completed (September 20, 1999)  
PCL # 1

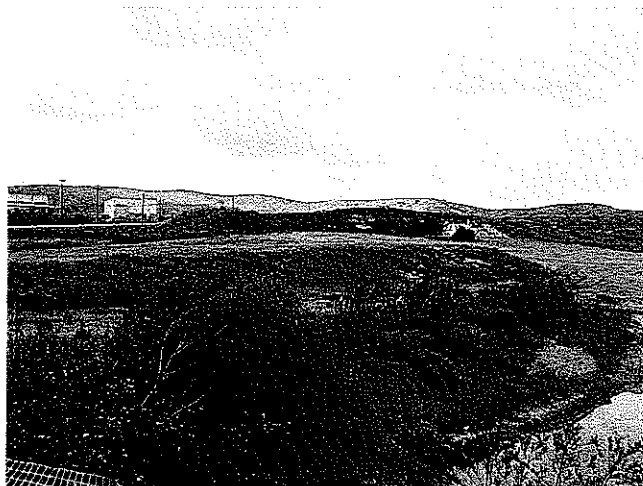
Site Grade Restored and Revegetated  
(looking toward west side of site)  
April 11, 2001

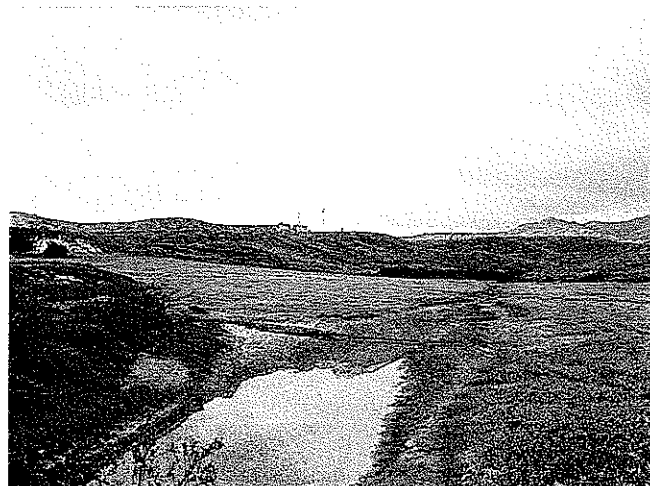
Center Drainage Swale Restored  
(looking toward north side of site)  
April 11, 2001

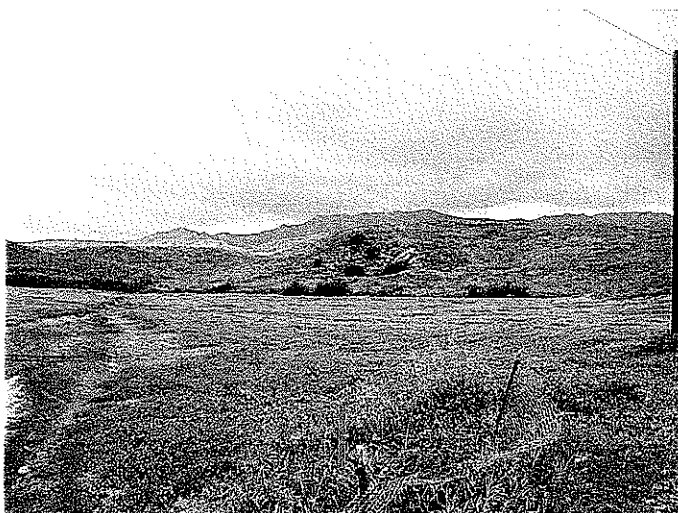
Site Grade Restored and Revegetated  
(looking toward northeast side of site)  
April 11, 2001

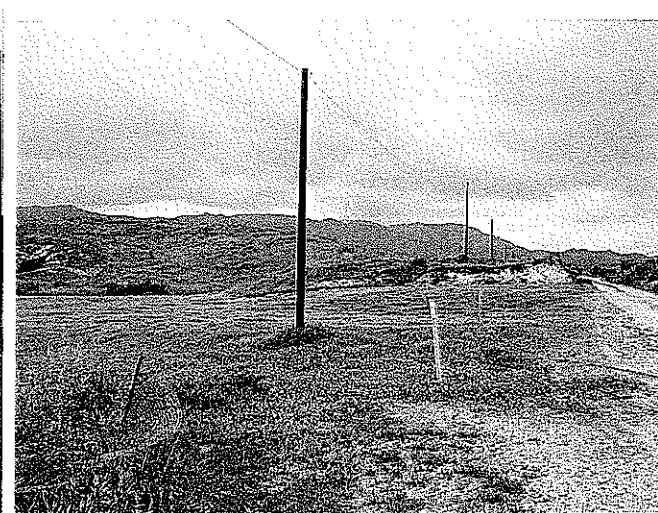
Access Road Restored  
(looking toward east side of site)  
April 11, 2001

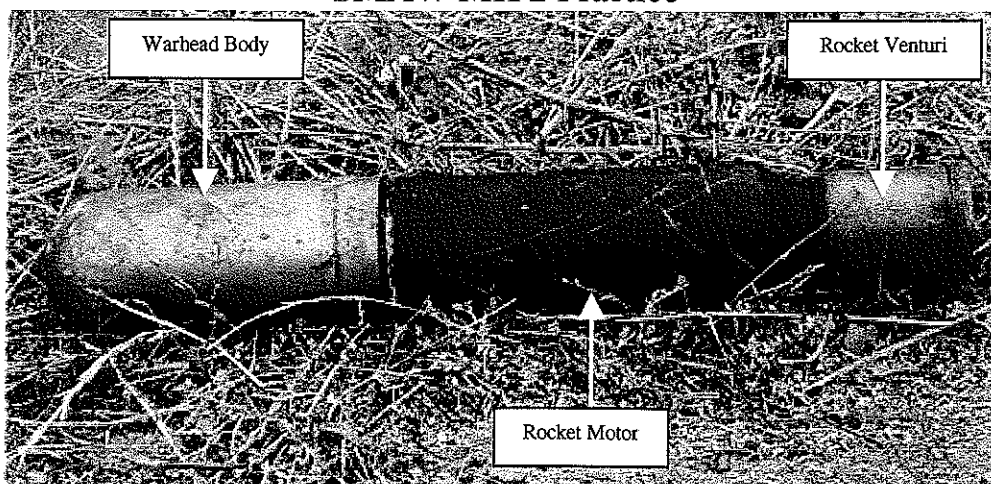
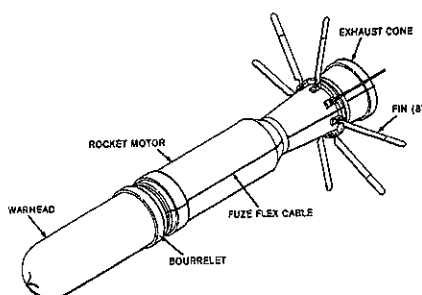
U.S. Rocket Assault, 83mm, Dual Mode  
SMAW MK 2 Practice

Date: September 10, 1999  
Excavation Number: 1F-06  
Location: Site 1F MCB Camp Pendleton, CA  
UXO Identification: Rocket Assault, 83mm, Dual Mode SMAW MK 2 Practice  
Depth Recovered: Surface  
Condition: Practice Ordnance, Rocket motor has been fired.  
Number of Items: 1 ea.

The ordnance item is a practice version of a tube launched unguided dual-purpose rocket. This item is exclusive to the United States Marine Corps. The only ordnance hazards for the practice version are the rocket motor and it's ignition system.

The ordnance item was found on the outskirts of the eastern side of the excavation area. The item was discovered during a walk around conducted by UXO personnel. The rocket was identified and checked to ensure the rocket motor had been fired. The item was deemed safe and was removed from the work area. Area workers were notified as to what was found and advised that additional items may be in the area. The practice ordnance will be kept until the completion of the project for use as a training aid. This item will assist non-UXO personnel in the recognition of UXO.
